JBR Inspections

Northwest front of the house

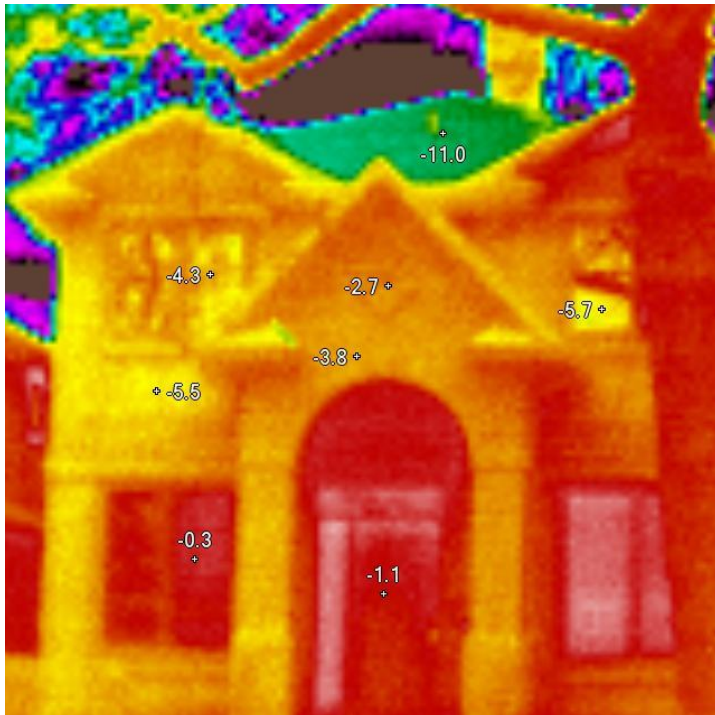
Southeast front of the house

We see more windows and the front door from a different angle. The windows on the upper levels are shown in this picture and there is no heat loss apparent from these windows.

You will notice the roof of the home is very cold indicating very good attic insulation and venting.

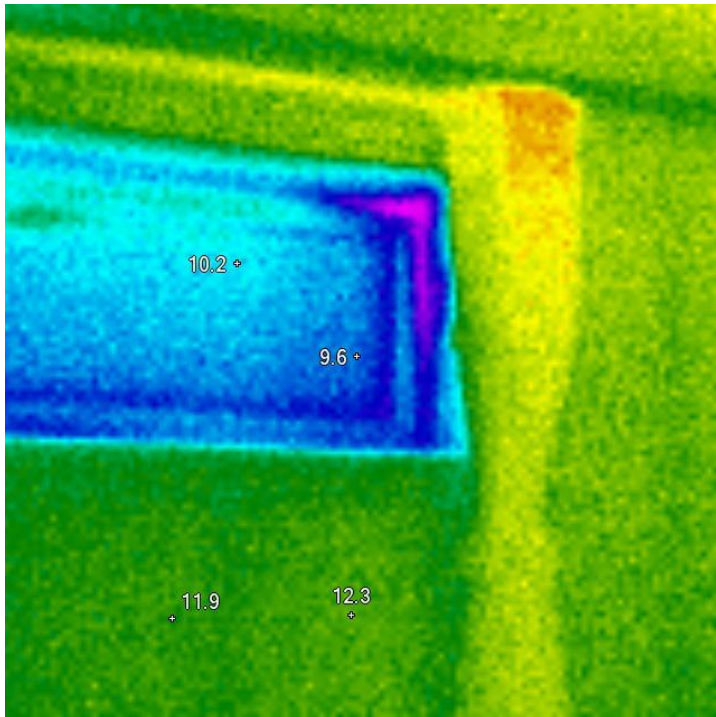
Southeast Bedroom Window

There is a slight change in temperatures noted, only 3 degrees. The progression of the surface area getting colder is normal as the cooler air at the top of the window will drop as it is heavier than warm air.

We are also looking for any moisture underneath the window, which would appear as a cool area below the window. We did not find any today.

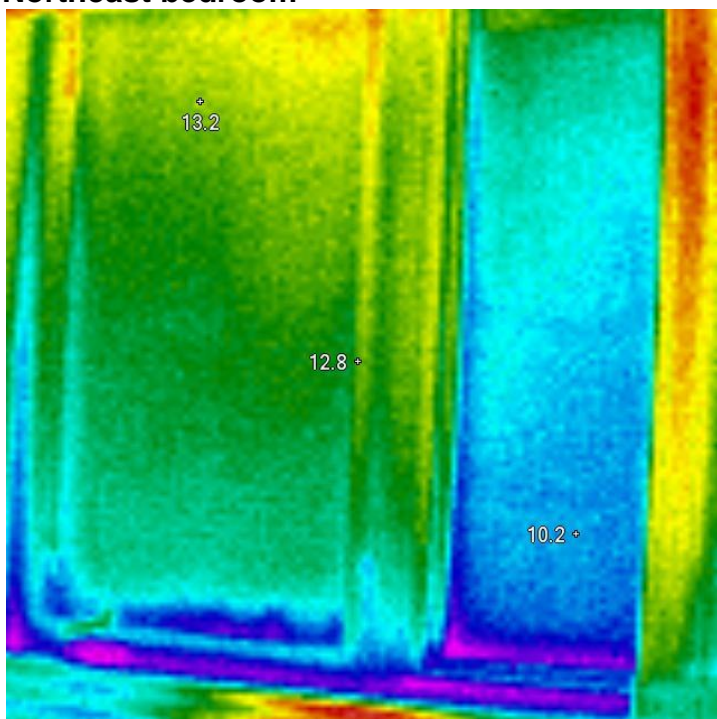
Northeast bedroom

The next two windows are consistent with these results
