**JBR Inspections**

**Northwest front of the house**

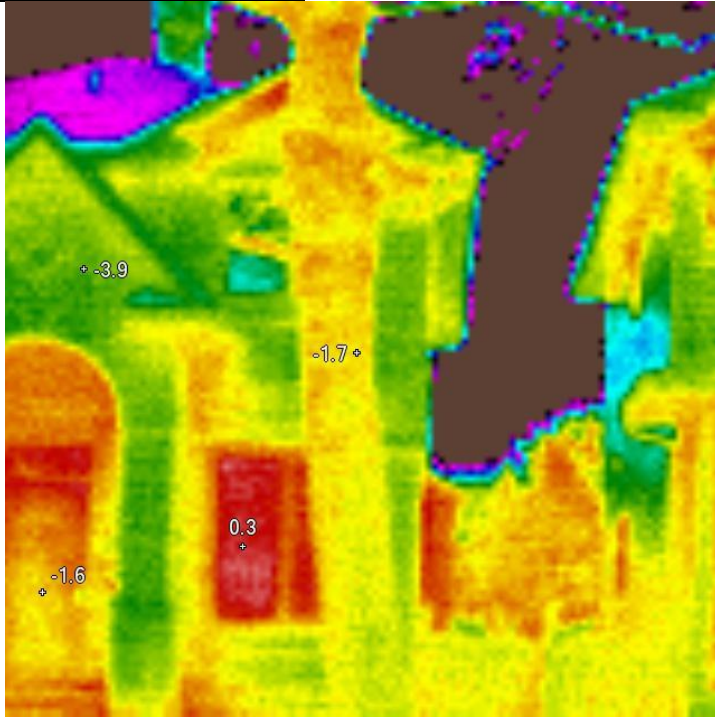
The windows and doors show slight heat loss which is normal. You can notice the temperature difference is only slight when comparing the siding to the actual window, indicating the windows are a good quality and in good repair.

There are no unusual areas of heat loss.

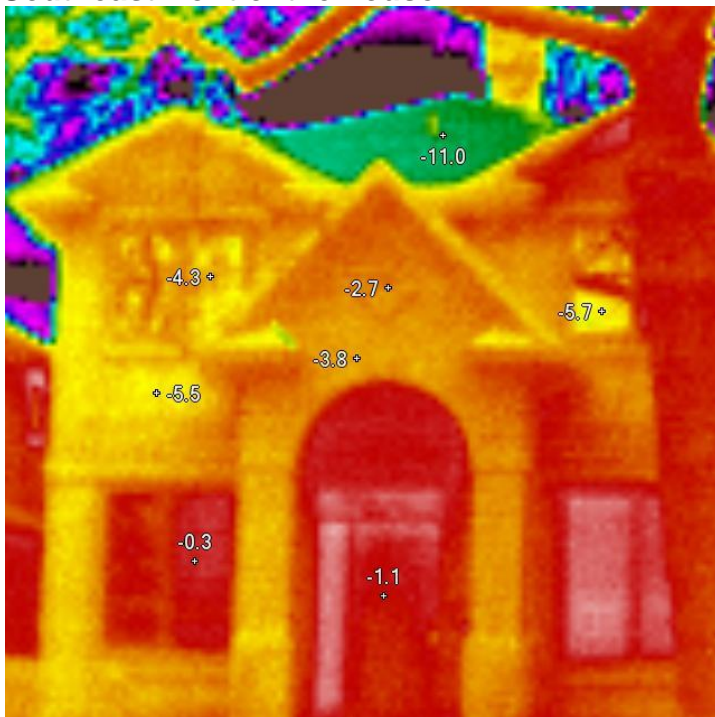
**Southeast front of the house**

We see more windows and the front door from a different angle. The windows on the upper levels are shown in this picture and there is no heat loss apparent from these windows.

You will notice the roof of the home is very cold indicating very good attic insulation and venting.

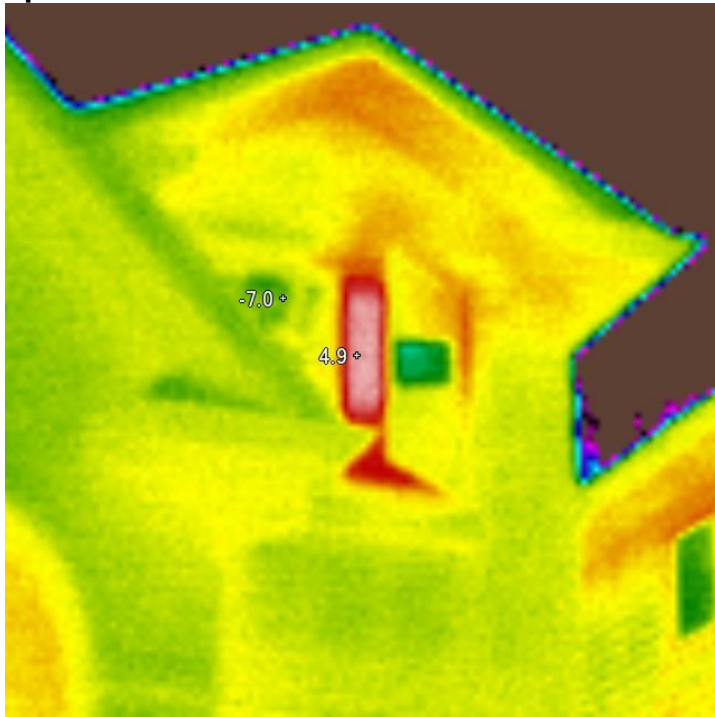
### Upstairs window northwest corner

The upstairs' window is open in this picture. The illustration shows the quality of the windows. The open area of the window is 12 degrees warmer than the closed side.

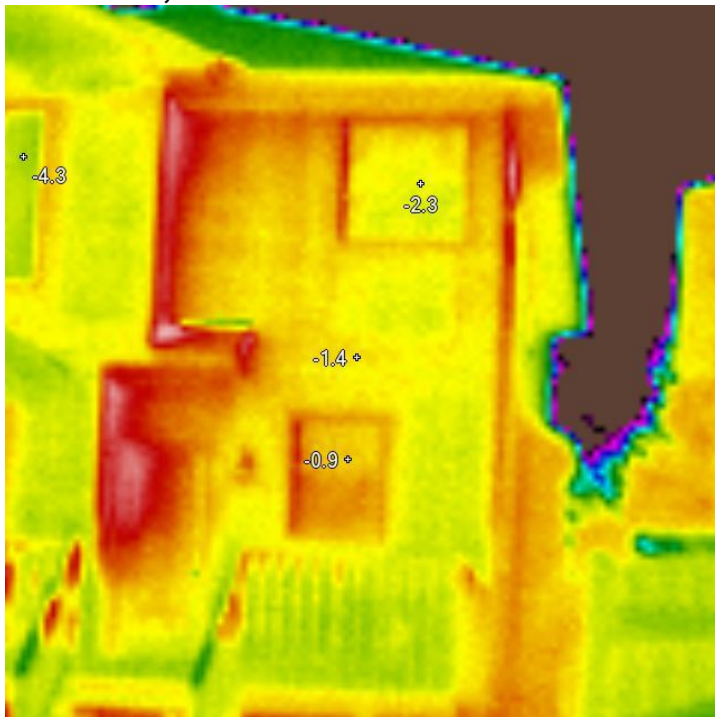
### North East, back of the house

The sun is starting to warm the siding and we can see warm areas (Dark Red) in spots where the sun is hitting the house directly.

The windows and door in the back of the house show little temperature change indicating they are performing properly

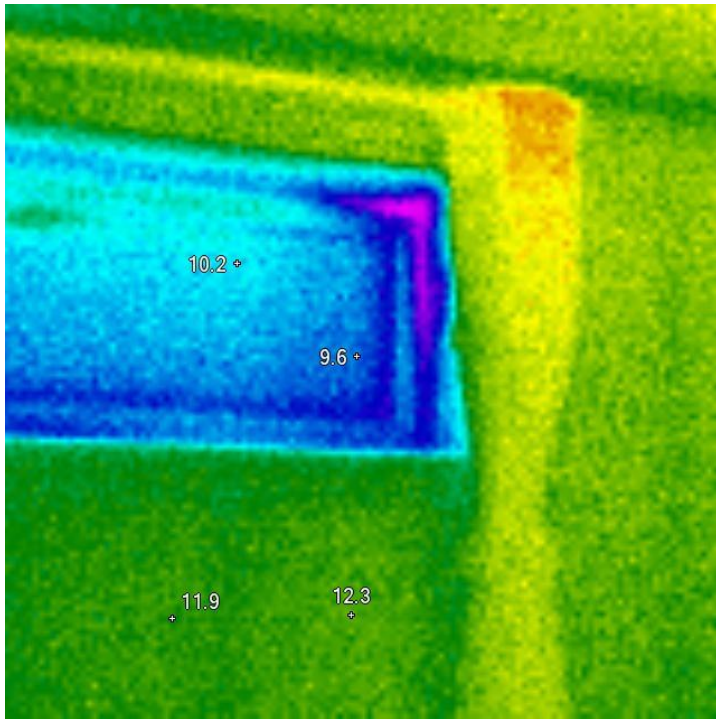
**Southeast Bedroom Window**

There is a slight change in temperatures noted, only 3 degrees. The progression of the surface area getting colder is normal as the cooler air at the top of the window will drop as it is heavier than warm air.

We are also looking for any moisture underneath the window, which would appear as a cool area below the window. We did not find any today.

The results are the same as the previous picture

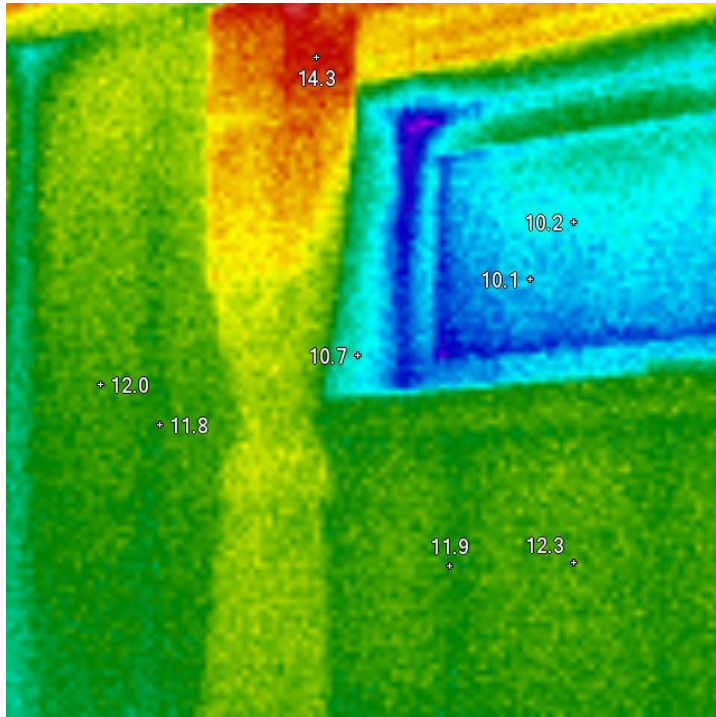
### Southwest basement window

The results regarding the window are the same as the previous two images.

In this image we can see the insulation and the framing in the wall. The framing is slightly cooler than the insulation and become visible to the thermal image camera. The insulation is very consistent in the wall

At the top right of the image there is a warm area. This is due to a heat register in the ceiling just in front of the window.

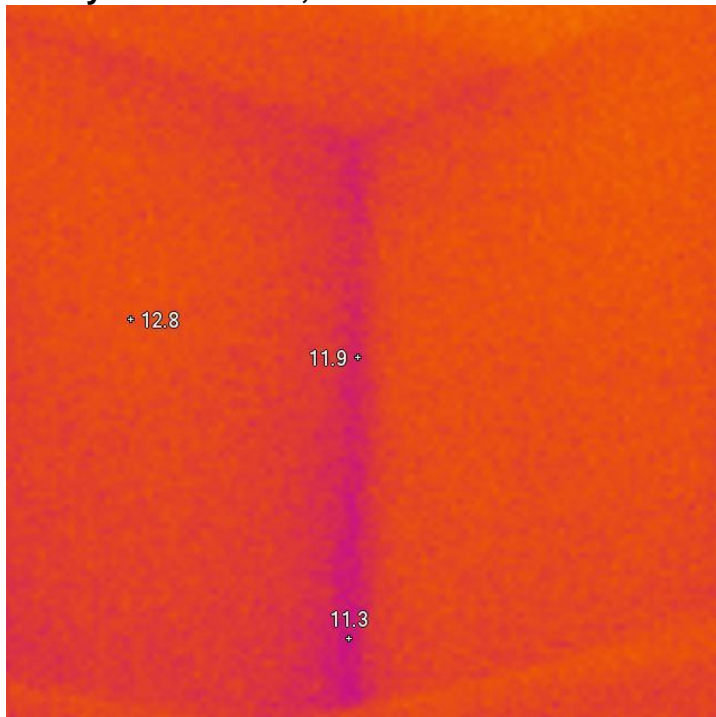
### Family room corner, Northwest

This image is the top corner in the family room. Corners are very hard to insulate so we analyzed this area. Although the corner appears very clearly in this image, the temperature difference is slight, only about 1 degree, indicating the insulation of the corner has been well done.

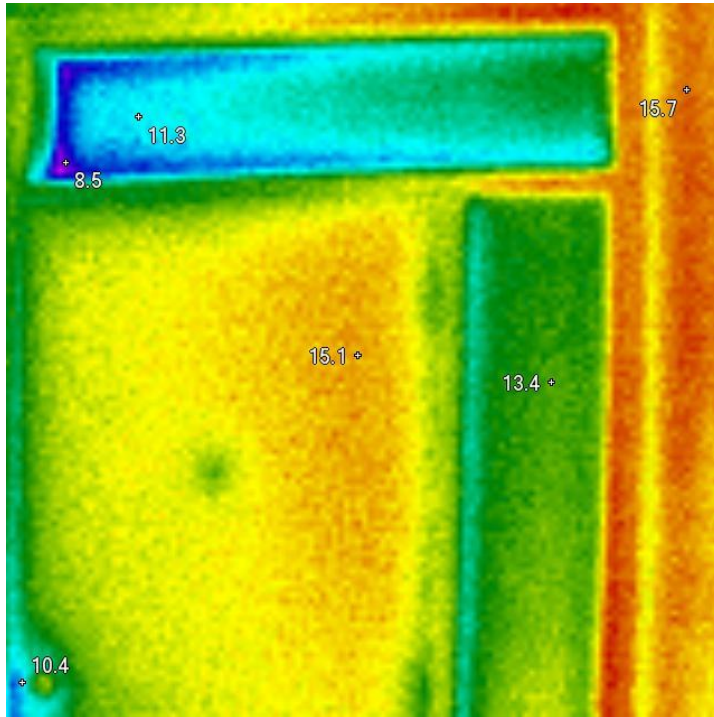
## Front door

The window above the front door has a very cold area in the lower left corner. This area may require a bit of re-caulking.

The door itself is performing very well almost matching the inside wall temperature.

There is a bit of a cold zone near the door knob. This is a hard area to insulate and is only a slight change in temperature.

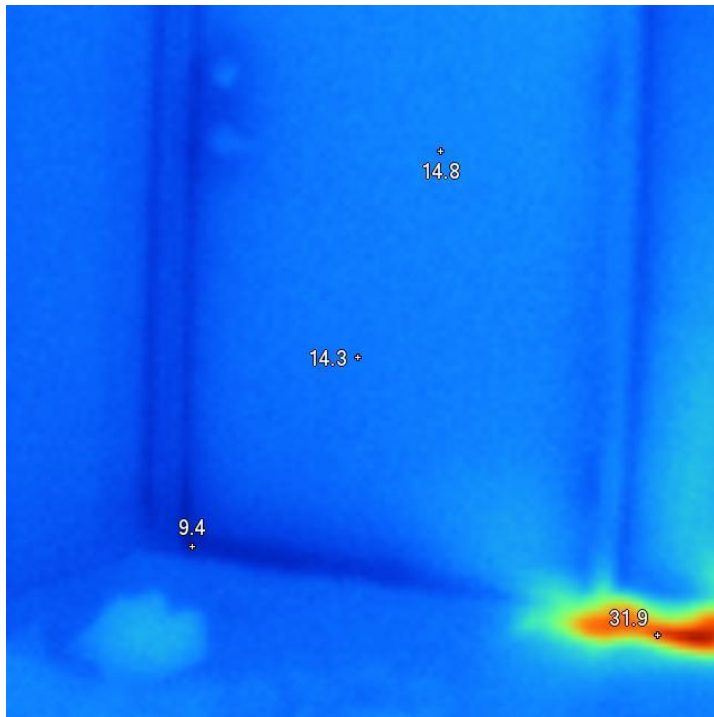
## The front door.

This is the lower area around the door. You can see the bottom left corner is much colder. Most exterior doors will have this issue. It can be corrected by adjusting or replacing the door sweep at the bottom of the door.

The warm spot at the bottom right is a heat register and the furnace is running.

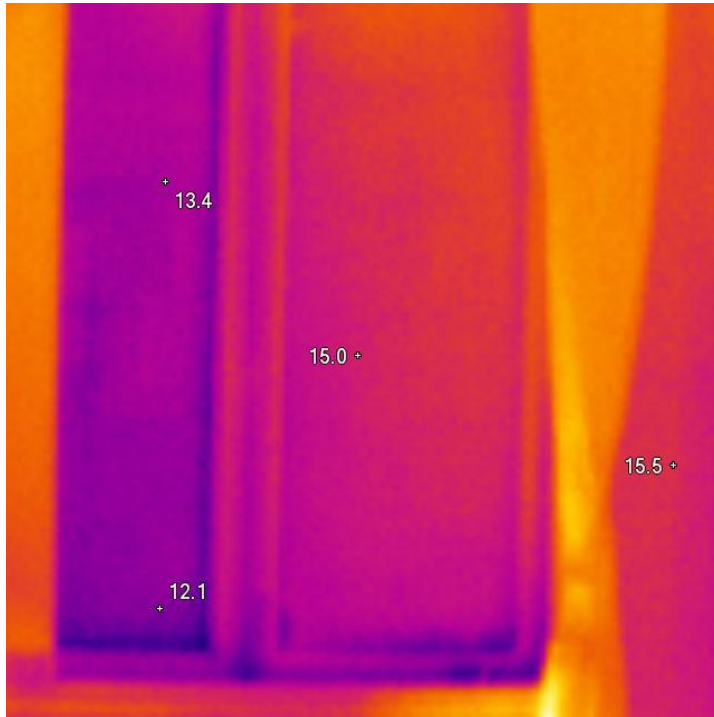
### The front window

This window is performing well, only slight temperature changes

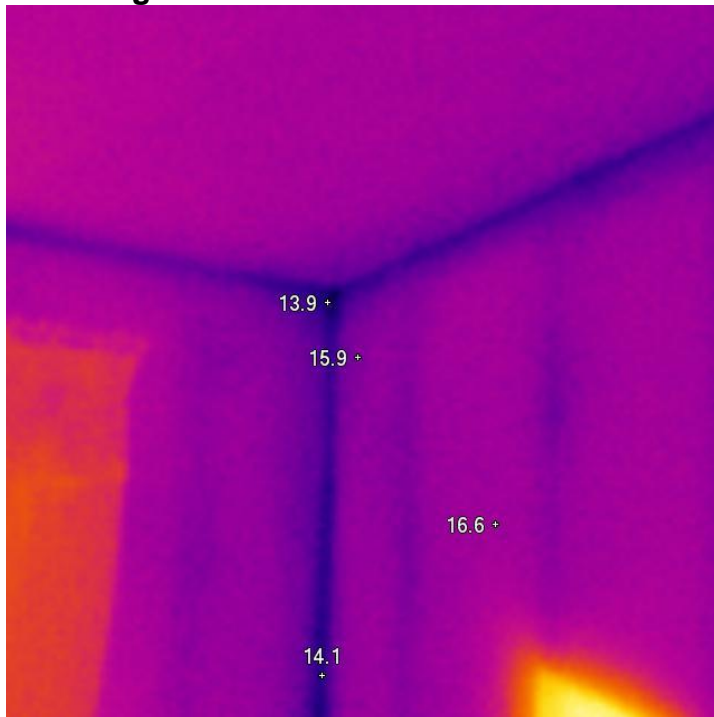
### The living room corner

We inspected this corner to analyze the heat loss, again it is minimal and indicates the corners are well insulated.

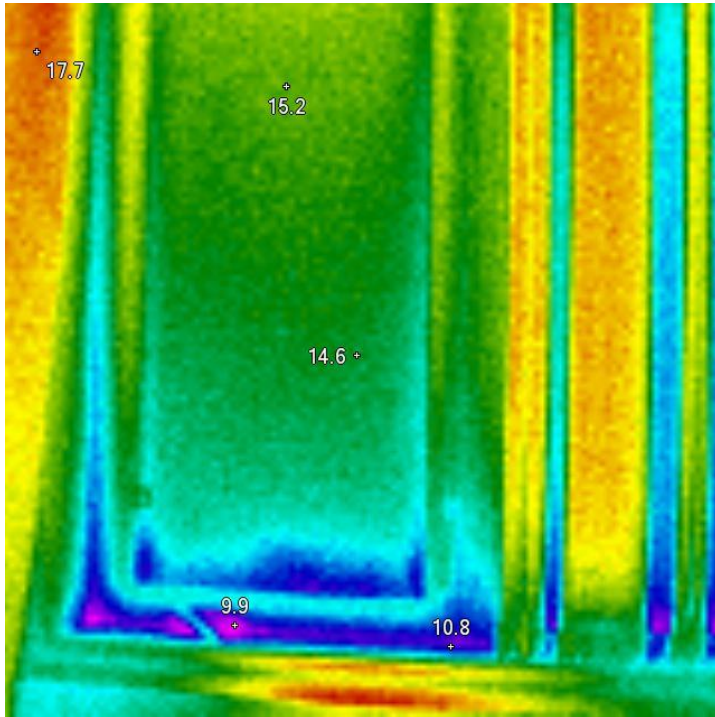
### East Window

This window is open slightly at the bottom, we can see the air leak but this also indicates the window is functioning well as the difference in temperature from the wall to the window is only 2 degrees.

After closing the window properly the cold area at the bottom of the window disappears.

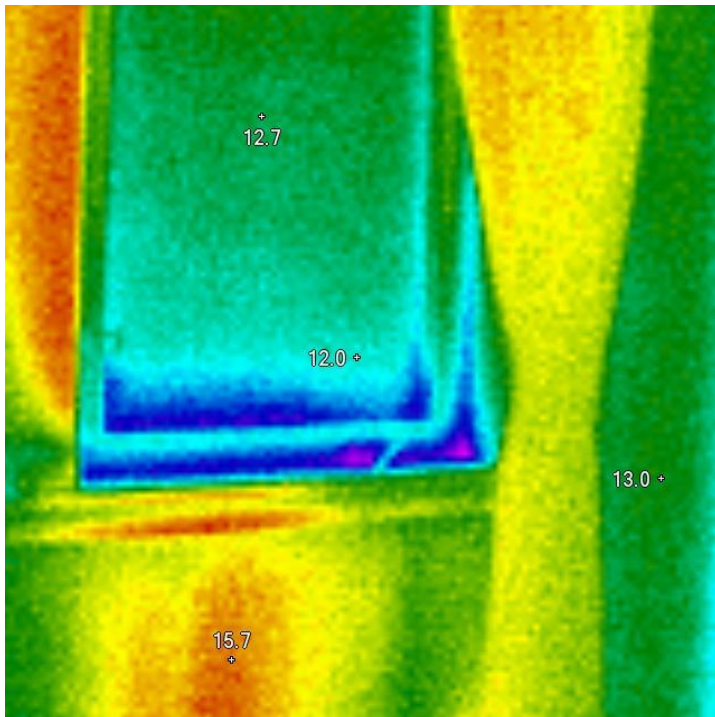
### North west window

Similar results as seen in the previous picture

The warm area near the bottom of the picture is due to a heat register with the furnace running.

The next two windows are consistent with these results

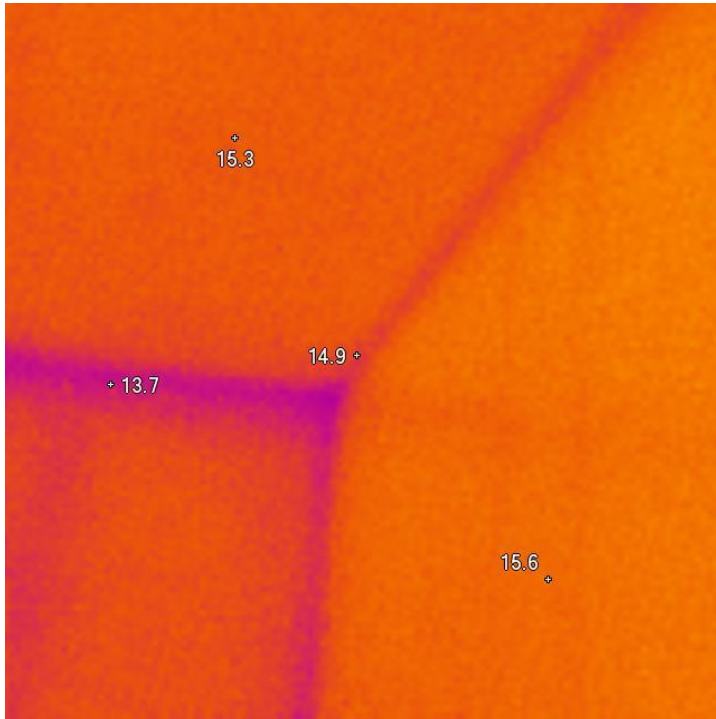
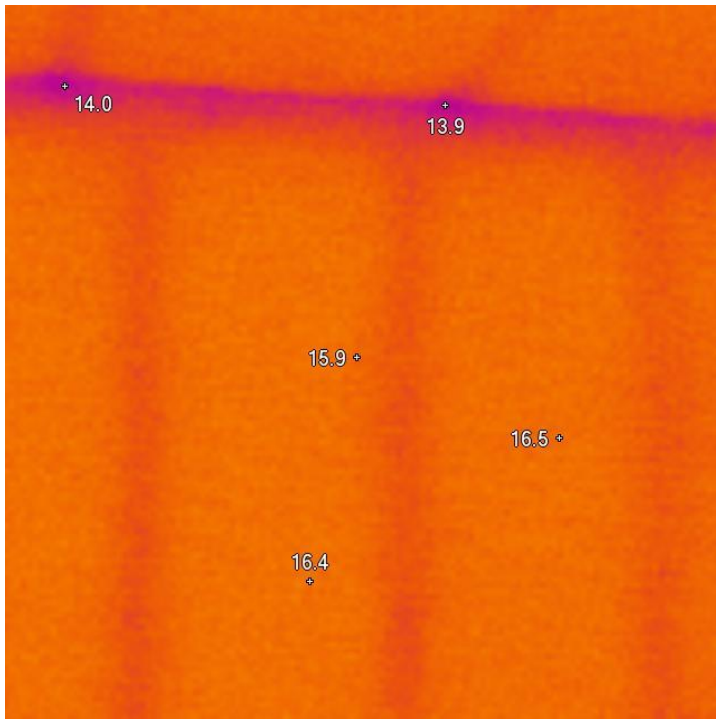
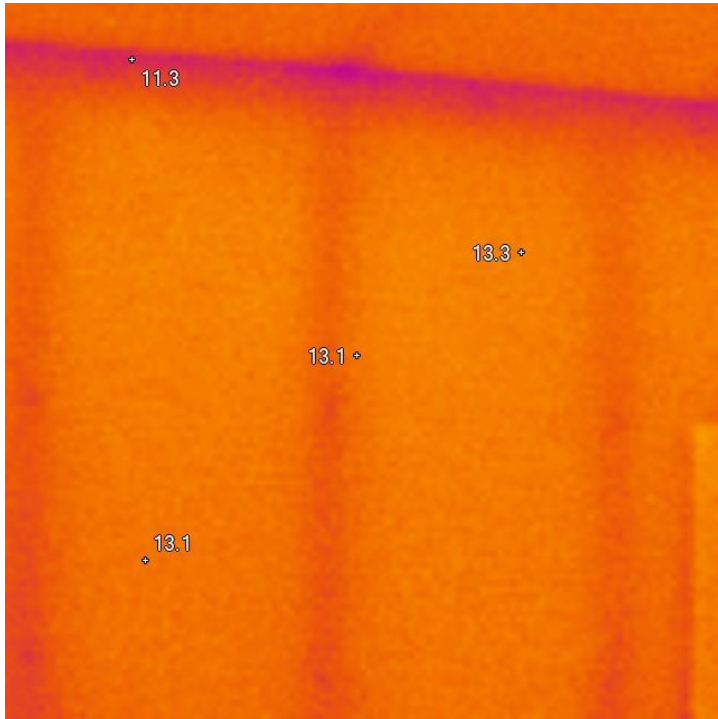
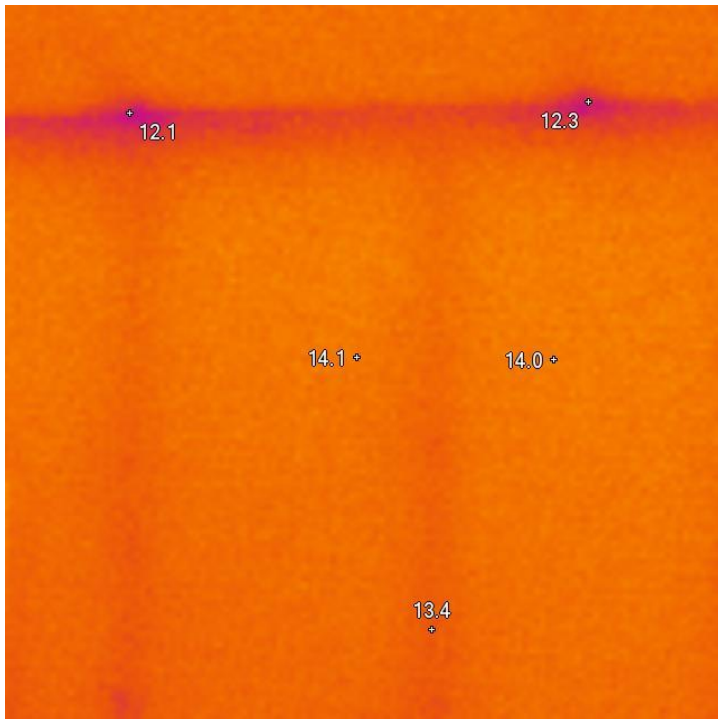
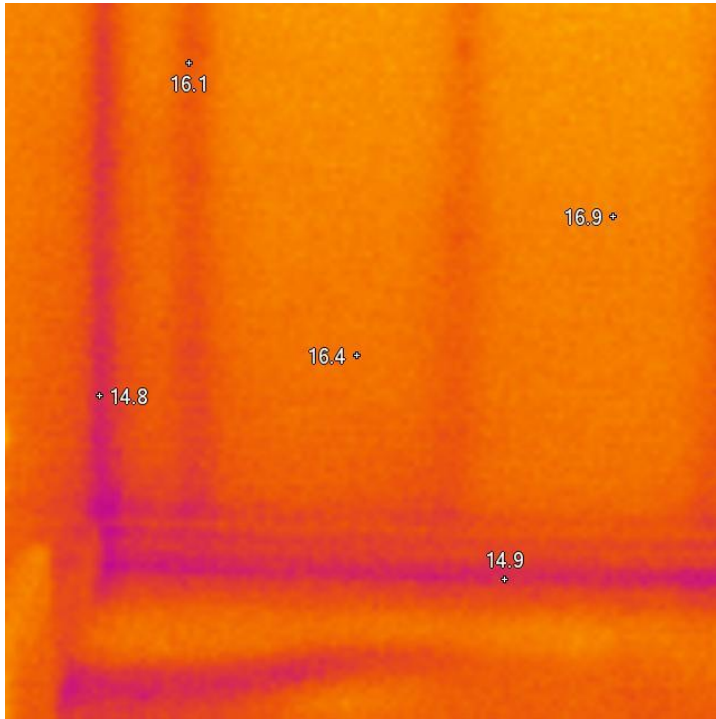
The following 5 Images are taken throughout the house and demonstrate the consistency of the insulation.

The entire building was viewed with the imager and these pictures represent the overall condition of the building. There were no pockets of missing insulation in any part of the house.

We do see a bit of heat loss in the tough to insulate areas of the home but the overall temperature difference is 2 degrees or less throughout the house, which is a very minor impact.
